**TANKS ILLUSTRATED NO. 9**

# Last of the **Panzers**

**German Tanks 1944-45**

**WILLIAM AUERBACH**

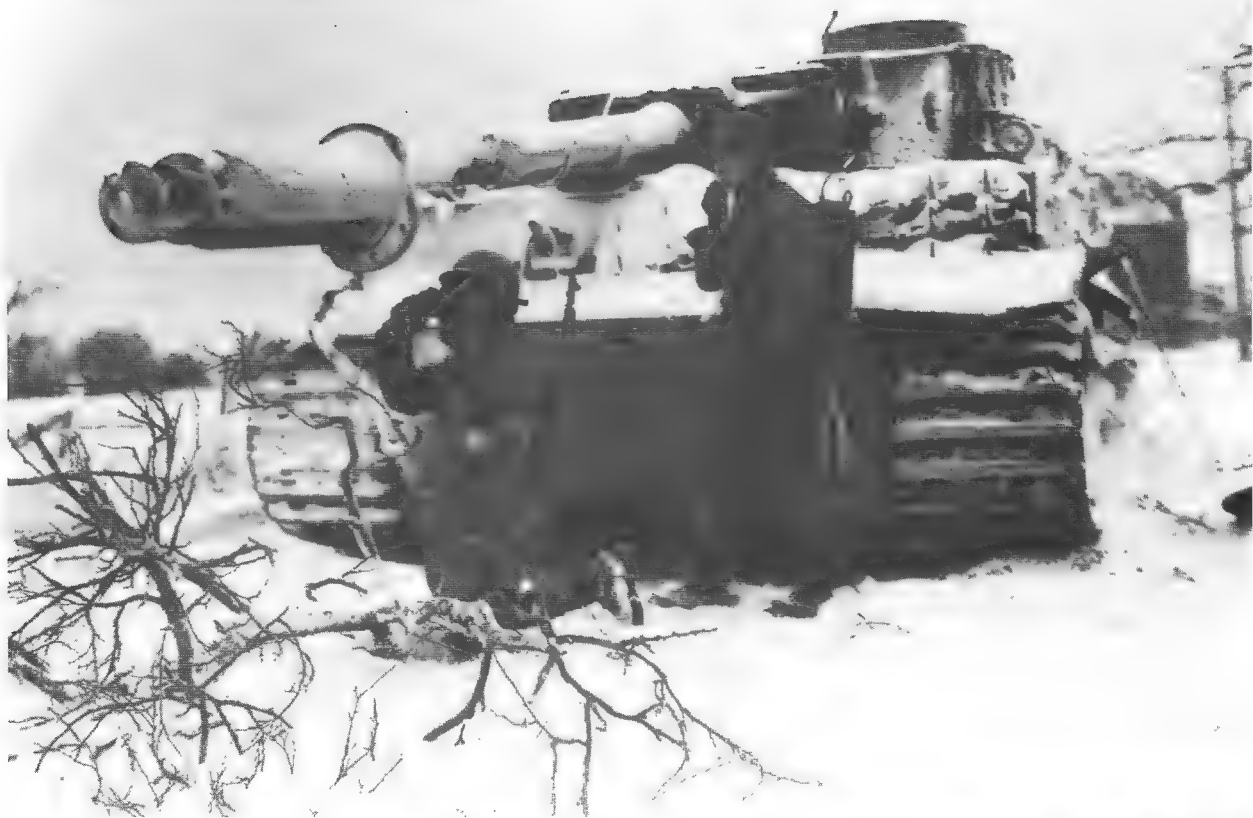
85▲ 86▼

**85.** Mortar observers from the 358th Infantry Regiment, 90th Infantry Division set up shop in front of a Tiger I Ausf E of the Panzerabteilung (Funklenk) 301, knocked out near Oberwampach, Luxembourg, 21 January 1945. This Tiger was used to control up to three B IV demolition vehicles. The muzzle brake has kept the barrel sleeve from being blown completely off the vehicle.

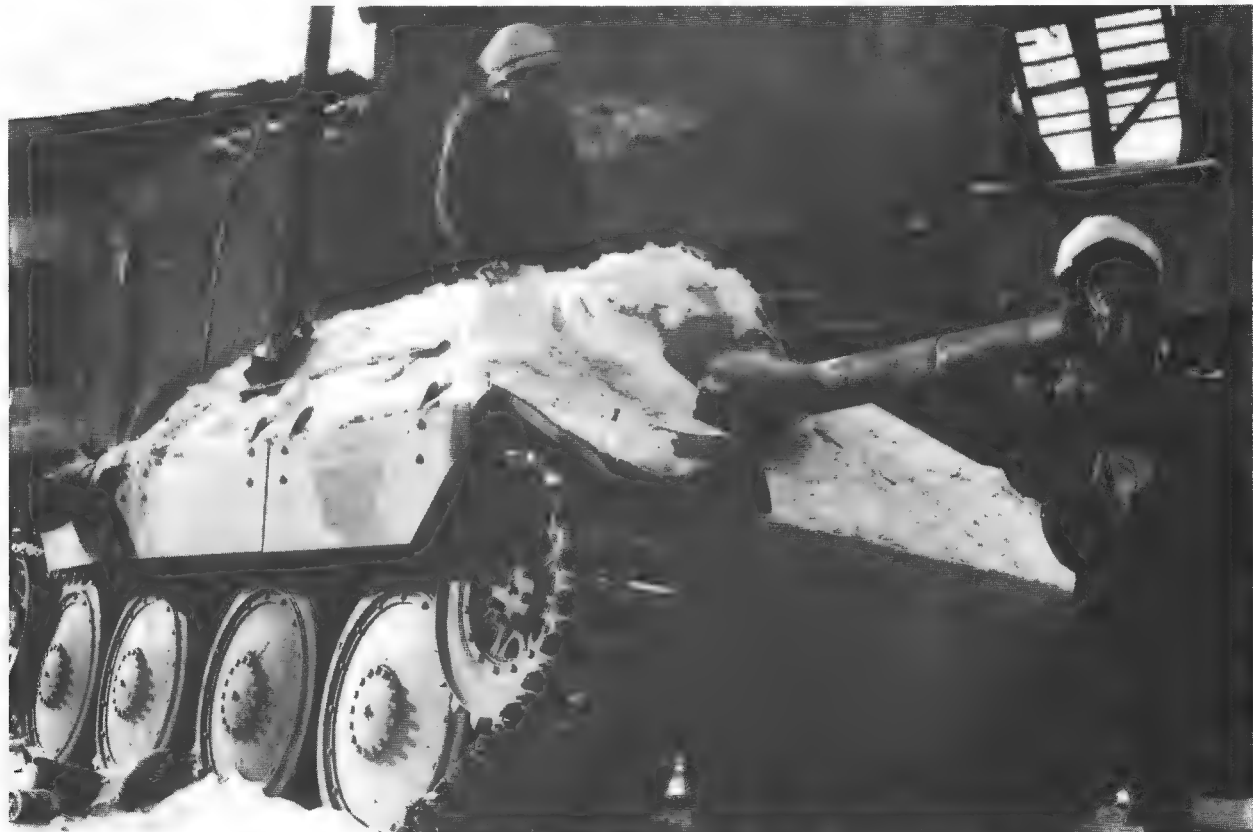
**86.** A Flammpanzer 38(t) knocked out in Gros Rederching, France, by the 114th Infantry Regiment, 44th Division, 13 January 1945. Note the longer, sheet-metal false barrel which looks like an ordinary cannon. The bottom of this dummy barrel is slotted from the muzzle down to the projector barrel to prevent flaming fuel dripping back on the vehicle. Note the spare track on the superstructure side.

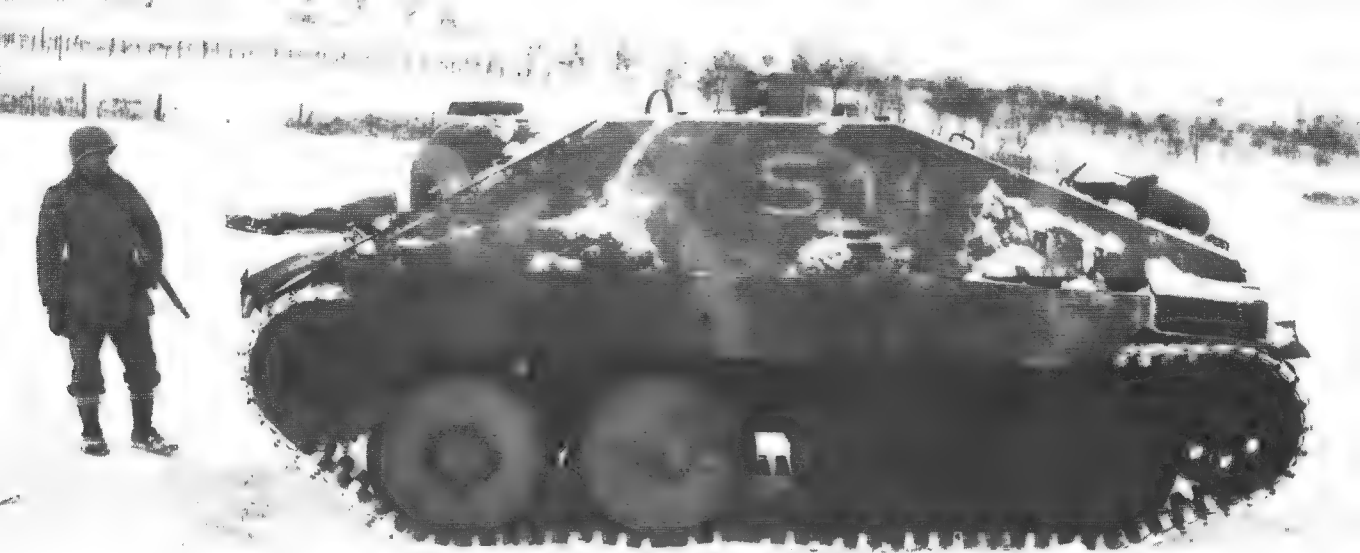
▲87 ▼88

87. Side view of another Flammpanzer 38(t) captured in Oermingen, France and photographed on 23 January 1945. Used first by the 17th SS PzGren Div., these tanks caused great losses for US forces of the 100th Infantry Division and the 2nd French Armoured Division when used around Rimling, France. This vehicle has a vertically-mounted muffler, spoked, 8-hole idler and the number 'S14' stencilled on its side. Note the small, crimped cowl over the flame projector barrel.

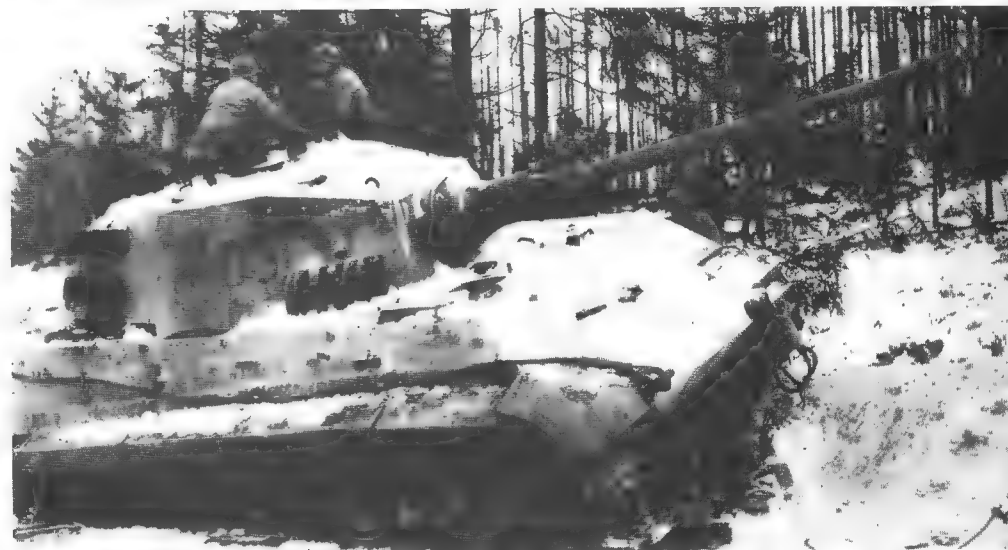
89▲

89. A whitewashed M3A1 halftrack of the 6th Armored Division passes a shattered Pz Kpfw IV Ausf J most notable for the new swivel hatch for the commander's cupola which replaced the hinged type. Destroyed in the Belgian town of Foy, near Bastogne, in January 1945, this vehicle has wire mesh schurzen, ice grips in its tracks, and the late-pattern muzzle brake.

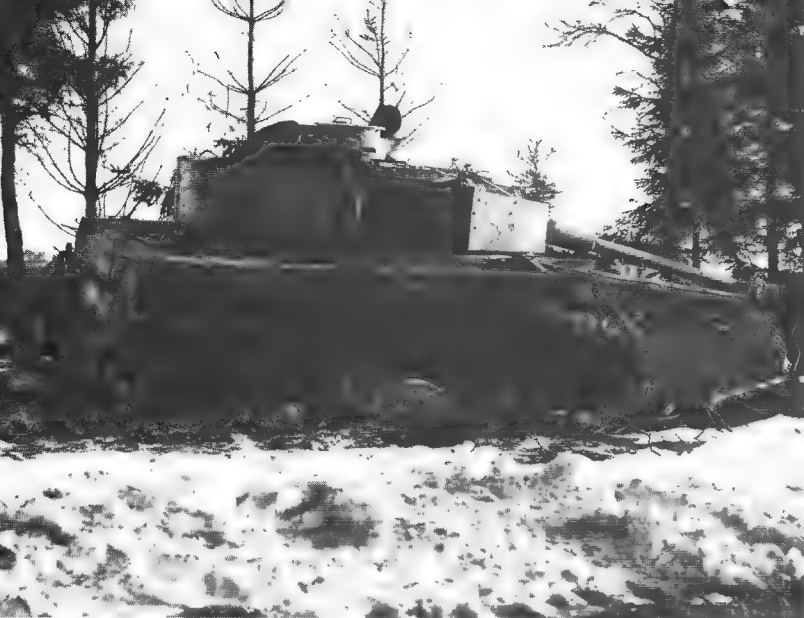
▲92

92. A very interesting shot of a Pz Kpfw IV Ausf J with commander's swivel hatch, knocked out in Luxembourg by Ninth Air Force fighter-bombers. These hatches were fitted with a grab handle and pivoted at the three o'clock position. The pipe bracket for the mesh schurzen is clearly shown. The vehicle has the early idler, four steel return rollers and pistol ports in the turret doors. The number '332' appears on the forward turret schurzen along with stencilled man with raised sword on rearing horse insignia. 11 February 1945. (US Air Force Photograph)

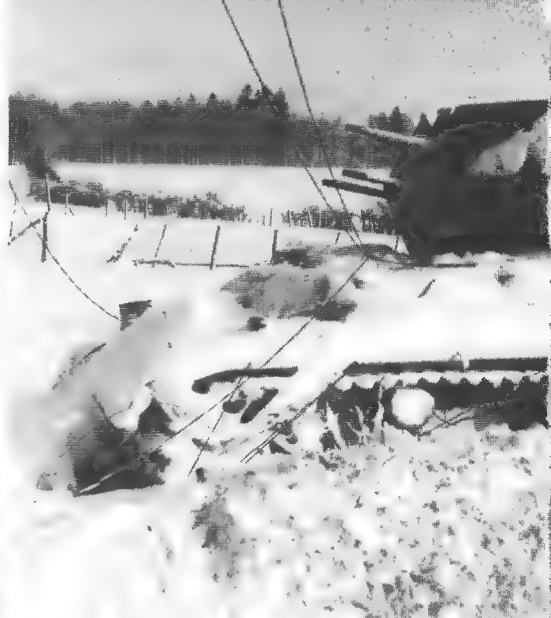
▲93

93. This snow-covered 'Wirbelwind' was captured in Belgium on 27 January 1945, and was to be sent back to the USA by Third Army Ordnance Int. for further study. One of the 2cm FlaK guns is missing as are all of the flash hiders on the remaining guns.

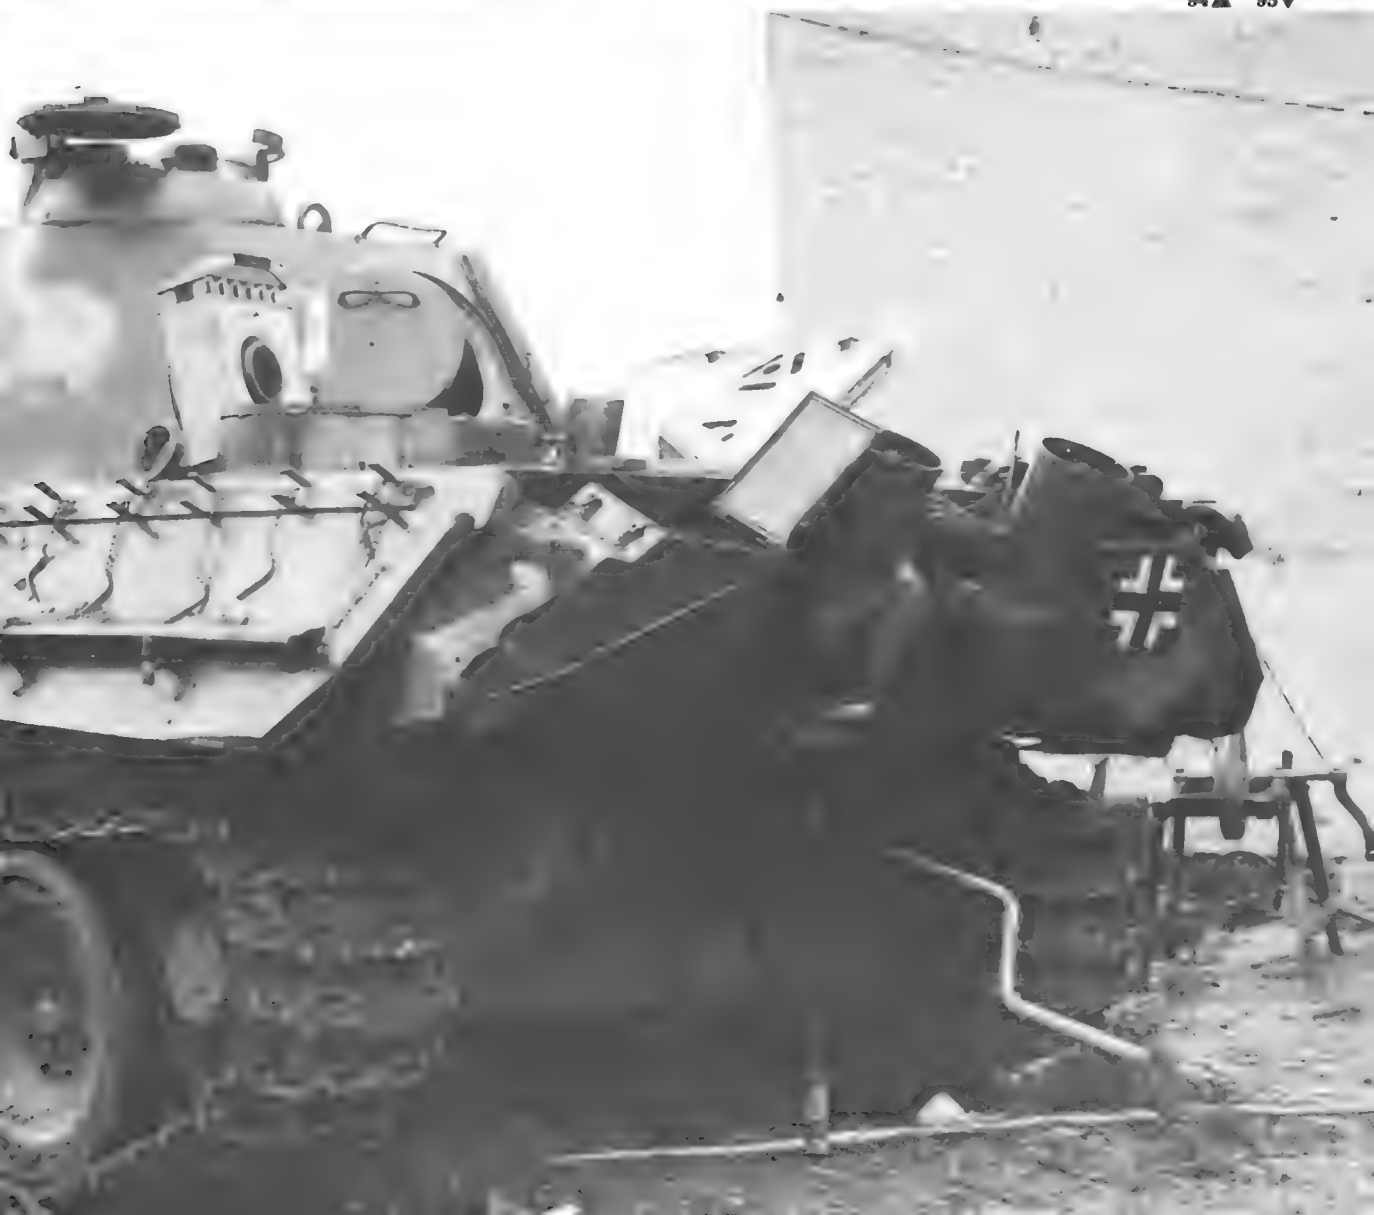
▲96 ▼97

96. US anti-aircraft crewmen swarm over a 'Möbelwagen' destroyed in the town of Hosingen, near the Siegfried Line. The bow MG was not fitted to these particular vehicles, and the superstructure was extended further over the trackguards. Note how the shields have shattered in this instance. The soldier with the carbine examines a German egg grenade. (US Air Force Photograph)

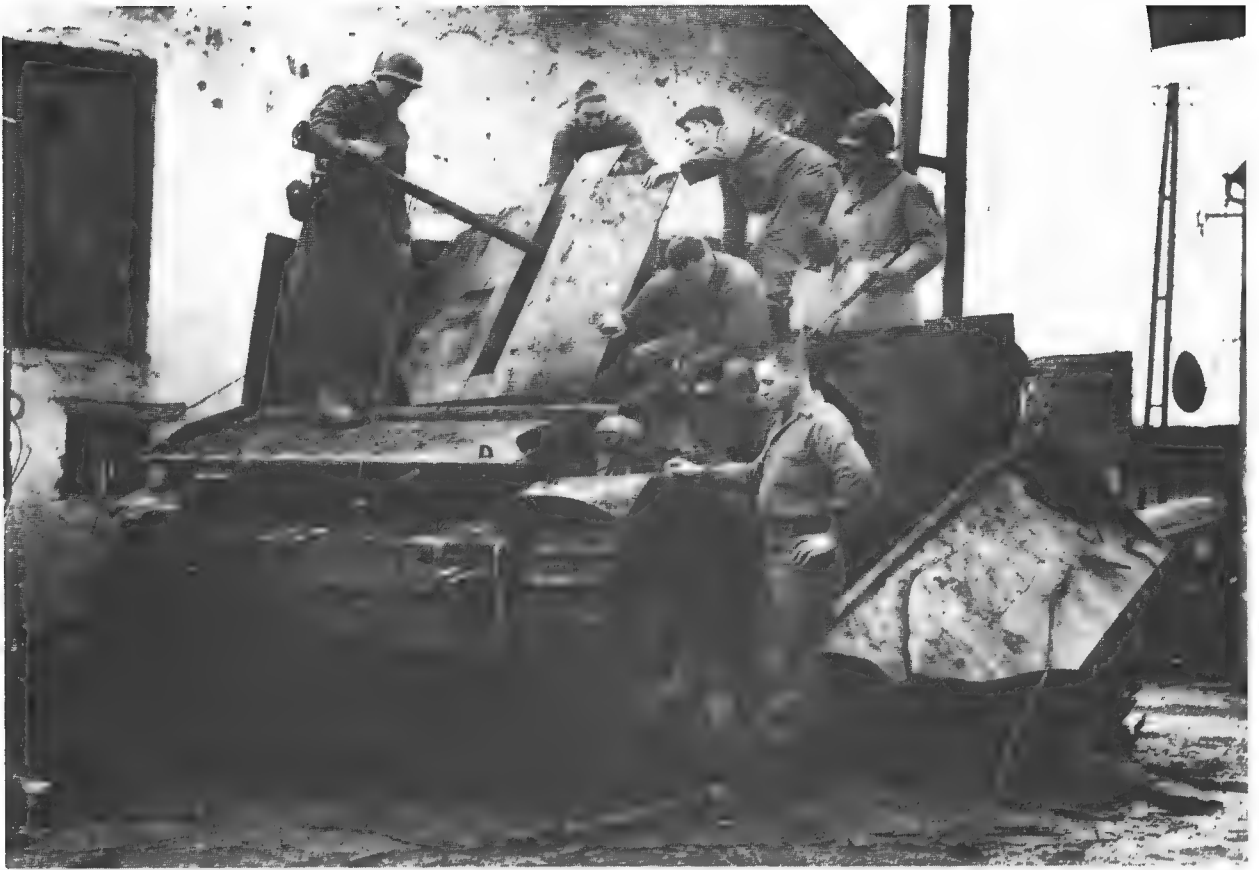
97. A bazookaman from the 142nd Infantry Regiment, 36th Division, looks over a Hetzer which has churned up the streets of Oberhoffen, France, before he knocked it out on 13 February 1945. The bulbous housing for the 7.5cm PaK39 L/48 is fitted

with the late-production mantlet. (US Army Official Photograph)

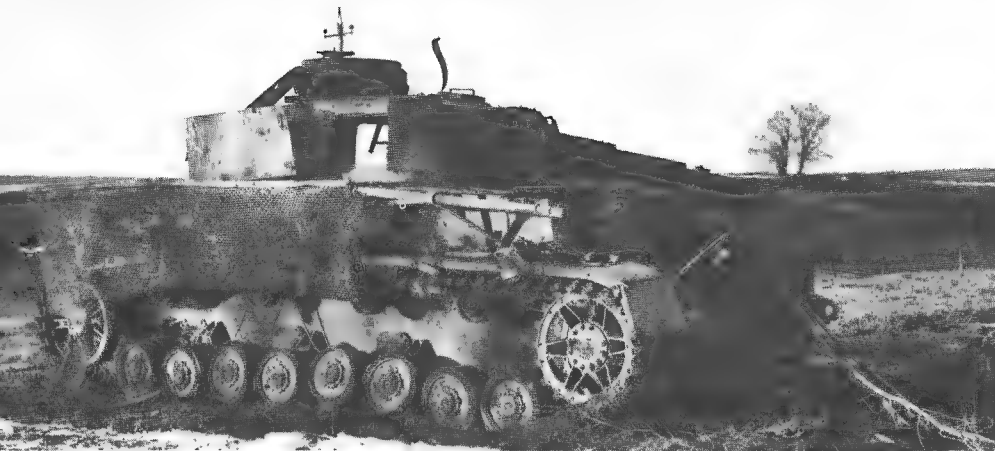
▲105

**105.** The penultimate Pz Kpfw IV Ausf J, its towing brackets formed from the extended hull sides, but still with four steel return rollers. Its 80mm front superstructure armour is clearly visible as is its bullet-riddled wire mesh schurzen. There are no pistol ports in the turret doors and the cannon is minus its muzzle brake. Quite possibly this vehicle had a commander's swivel hatch as well. Photographed in Luxembourg in 1945. (US Air Force Photograph)

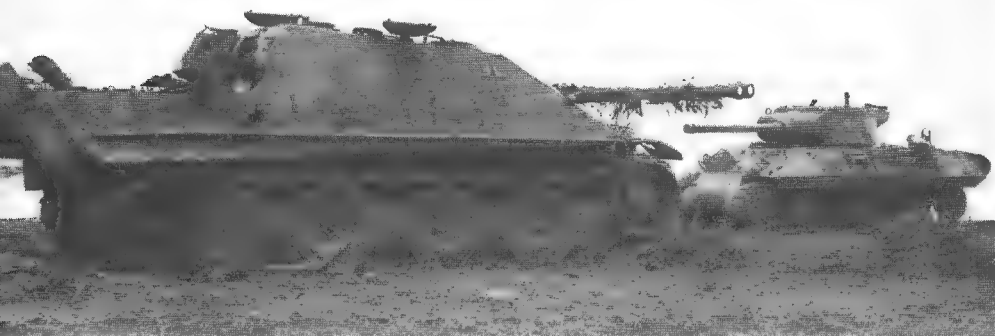
▲106

**106.** A Jagdpanther and an American M36 tank destroyer stand where they were knocked out in a field near Kaimig, Germany, 17 March 1945, mute evidence of the see-saw nature of attack and counterattack. The level ground and open spaces were ideal conditions for these tank destroyers' long-range, hard-hitting cannon. The Jagdpanther, no. '123', has the late-war idlers and the tube for the gun-cleaning tools across the engine deck. Note the large stowage box fitted on the rear of the superstructure.

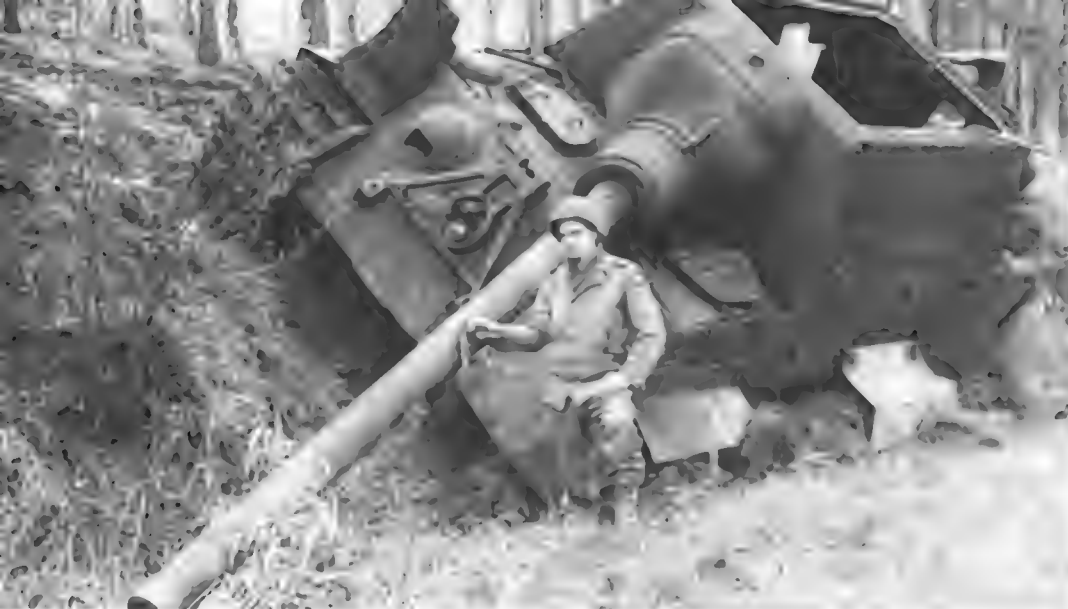
▲113

**113.** A Sherman tank of the 750th Tank Battalion is credited with destroying this Jagdtiger of the schwere Panzerabteilung 512, seen here in the woods of Offensen, Germany, 9 April 1945, after losing a track and sliding off the road. Note how the travel lock folds down over the headlamp, and the twin grab handles necessary to lift the swivel hatches for the driver and radio operator. The three 'Pilzen' for the emergency crane were welded to the front, side and rear tops of the superstructure.

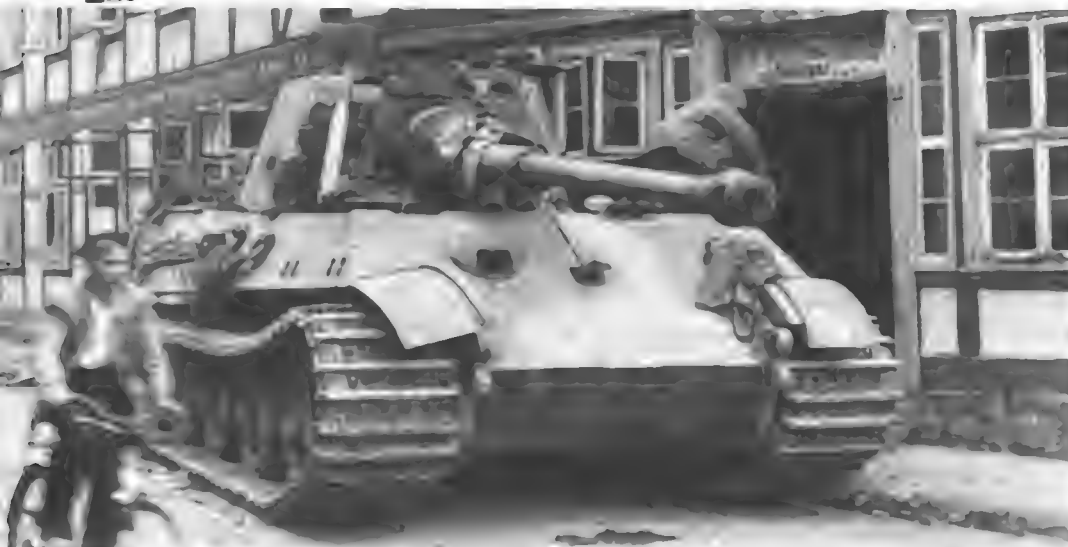
▲114 ▼115

**114.** Civilians in the town of Osterode, Germany silently watch a GI inspect a Tiger II which was knocked out by a 90mm round burning through the side of its turret. The Tiger is painted in the 'ambush' scheme and all the hatches are open. Notice how far the tracks extend past the hull sides and how the front slope of the turret roof gave the commander decent forward observation. An 88mm round is propped against the turret, testimony to the once formidable offensive power of this vehicle. 12 April 1945.

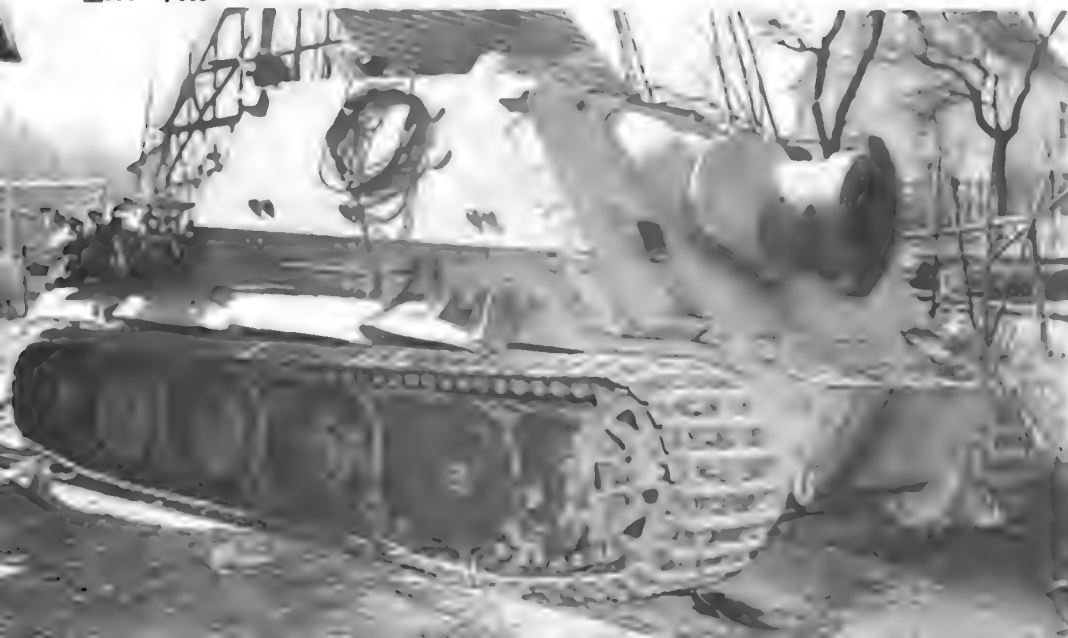
**115.** A Sturmmörser captured in the outskirts of Drolshagen, Germany by 8th Division infantrymen on 11 April 1945. These vehicles were designed to give close support to infantry in the assault on strongly defended localities, and this one was beefed up with additional armour bolted on the hull front. Note the massive counterweight, different brackets on the superstructure side and the absence of Zimmerit. The crane, ventilator and 'Nahverteidigungswaffe' on the roof are all visible.

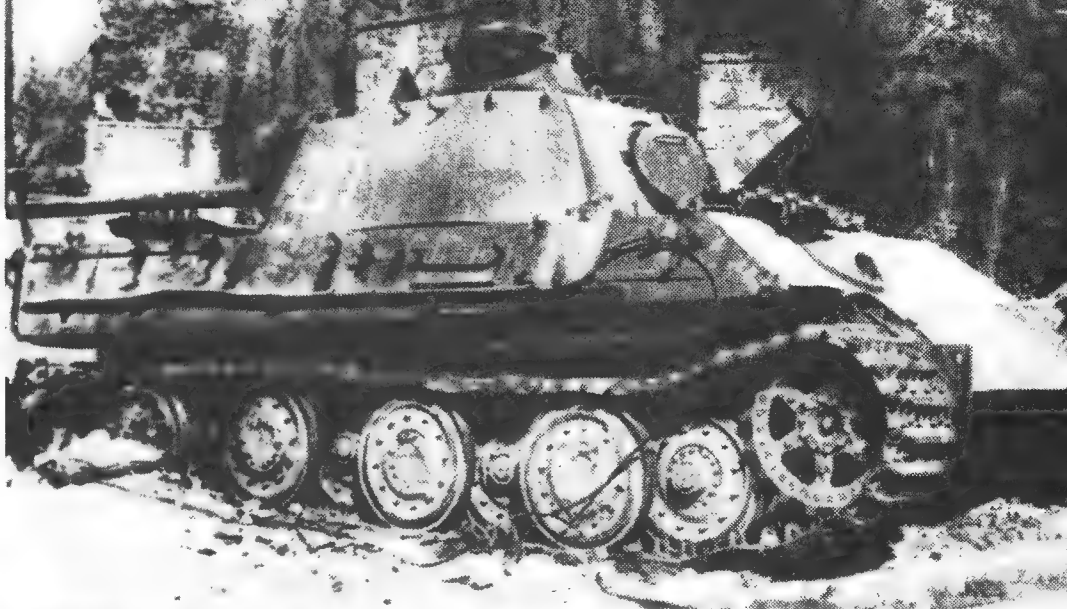
116▲

**116.** Front  $\frac{3}{4}$  view of a burned-out Panther Ausf G having the steel-wheeled suspension fitted. Note the condition of the rear portion of the suspension and how far the radio operator's hatch swung open.

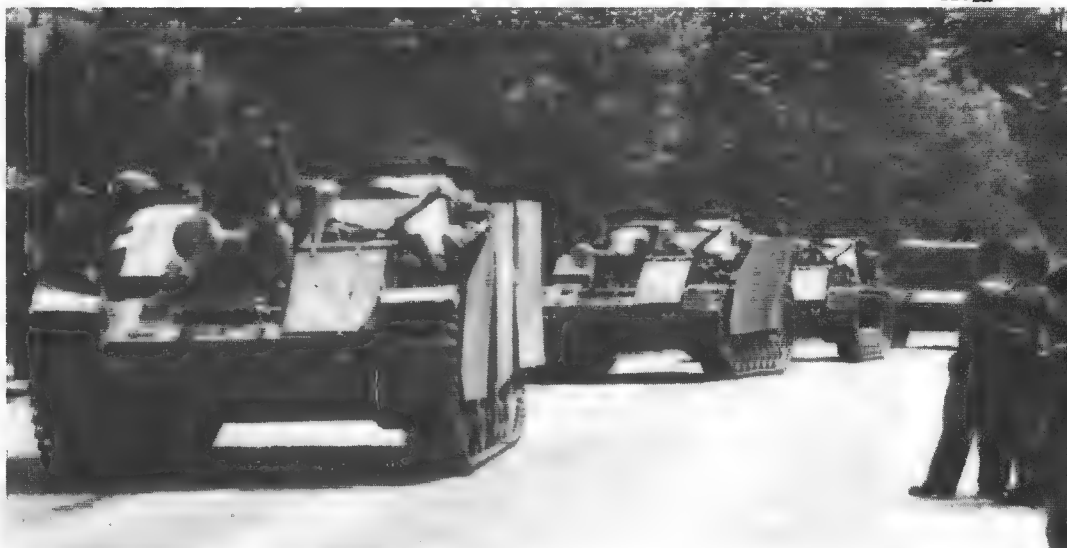
**117.** Crew members ride exposed on a line of Sturmgeschütz IVs moving into Ivea, Italy, to surrender to the US 34th Division on 5 May 1945. These vehicles have home-made travel locks, concrete on the right front superstructure and extra sloping armour plate fitted in front of the drivers' compartments. A Bergepanzer III brings up the rear.

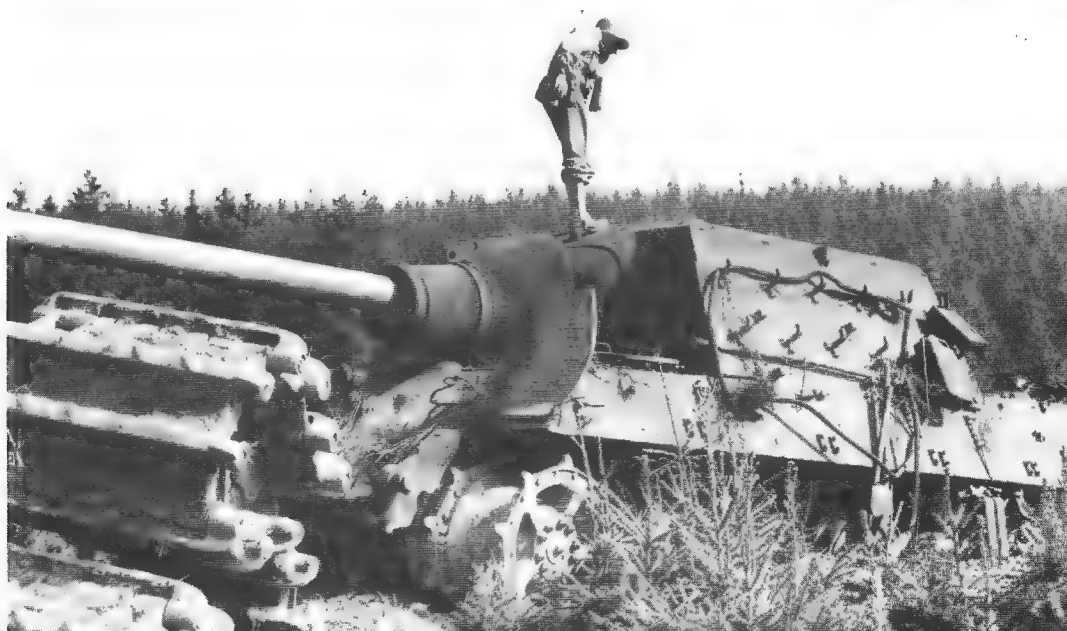
**118.** The redesigned track of this late-production Jagdtiger lies piled up where it was shed, allowing a view of the modified drive sprocket. In order to fit the new track, every other tooth of the old sprocket was cut off with a torch. The glacis and mantlet were heavily gouged by shellfire as it attempted to hold a strategic position overlooking a valley in the Harz Mountains near St Adreasberg, Germany, 16 April 1945.

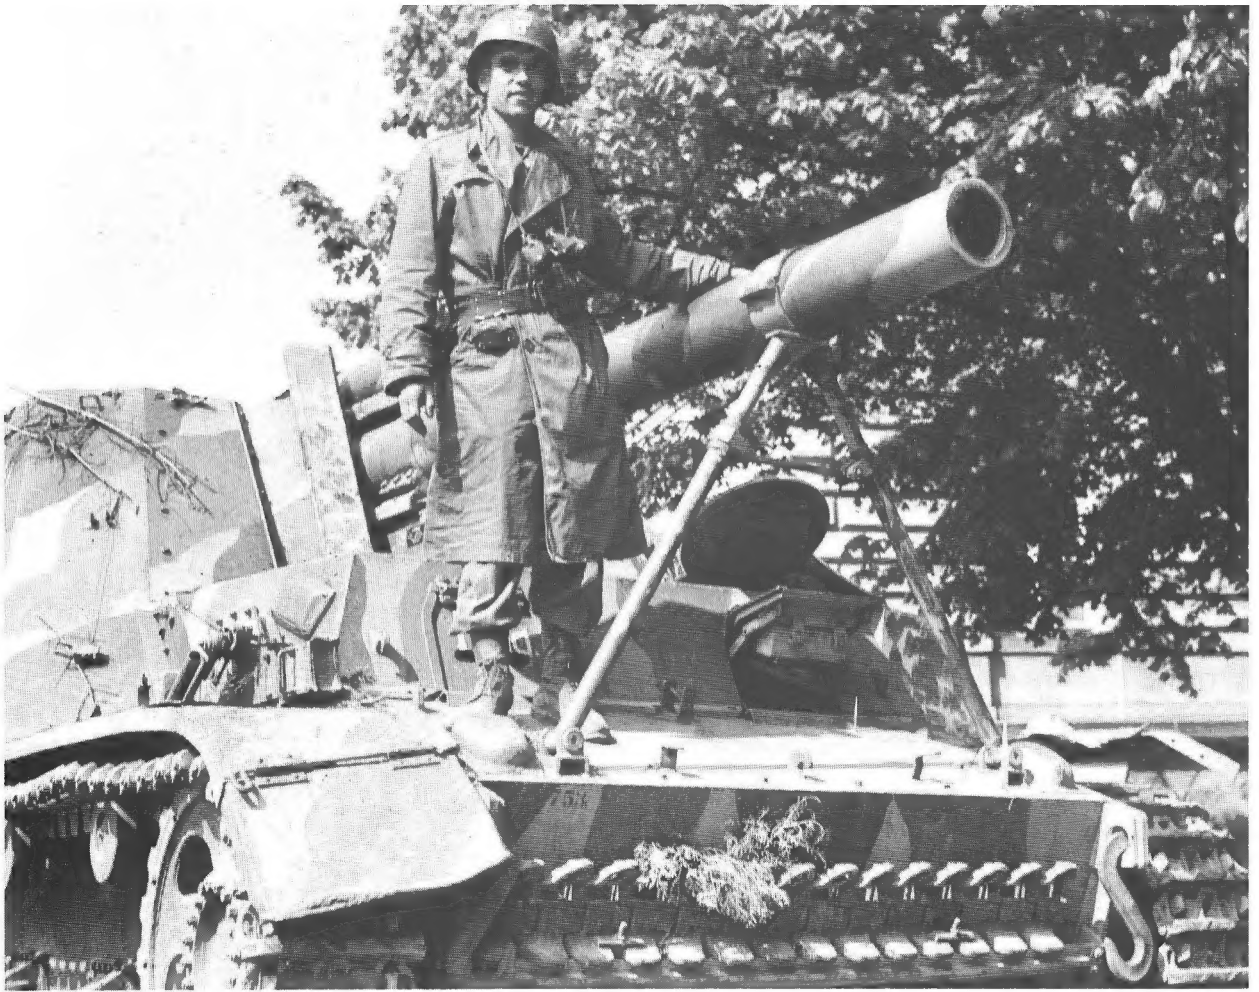
▲119

**119.** An interrogation officer with the 69th Infantry Division poses atop a 15cm schwere Panzerhaubitze Pz Kpfw III/IV 'Hummel' which he captured single-handed near Wurzen, Germany, 25 April 1945. This vehicle has the standard three-colour camouflage scheme and the driver's full-width compartment introduced from early 1944. The aiming spikes on the glacis presumably enabled the driver to align the 'Hummel'.

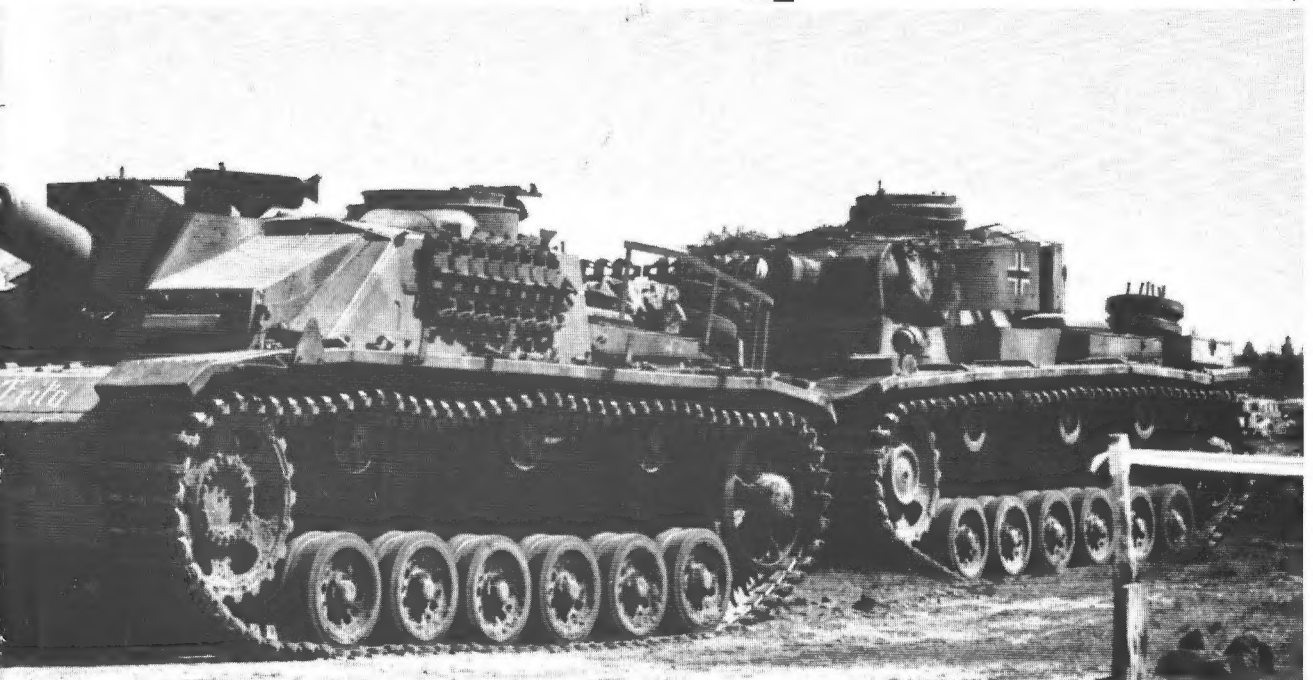
122▼

**122.** An interesting collection of AFVs surrendered to the Canadians. In the foreground are two StuG III Ausf Gs with spoked steel return rollers, remote-controlled MGs, coaxial MGs in the mantlet, travel locks, late-pattern muzzle brakes and no zimmerit. Both have a good share of kill rings and both carry women's names on their hulls. Next to them is a StuG III Ausf D, retroactively fitted with an MG shield for the gunner. Behind them is a Pz Kpfw III Ausf N. (PA-52083/Public Archives of Canada)

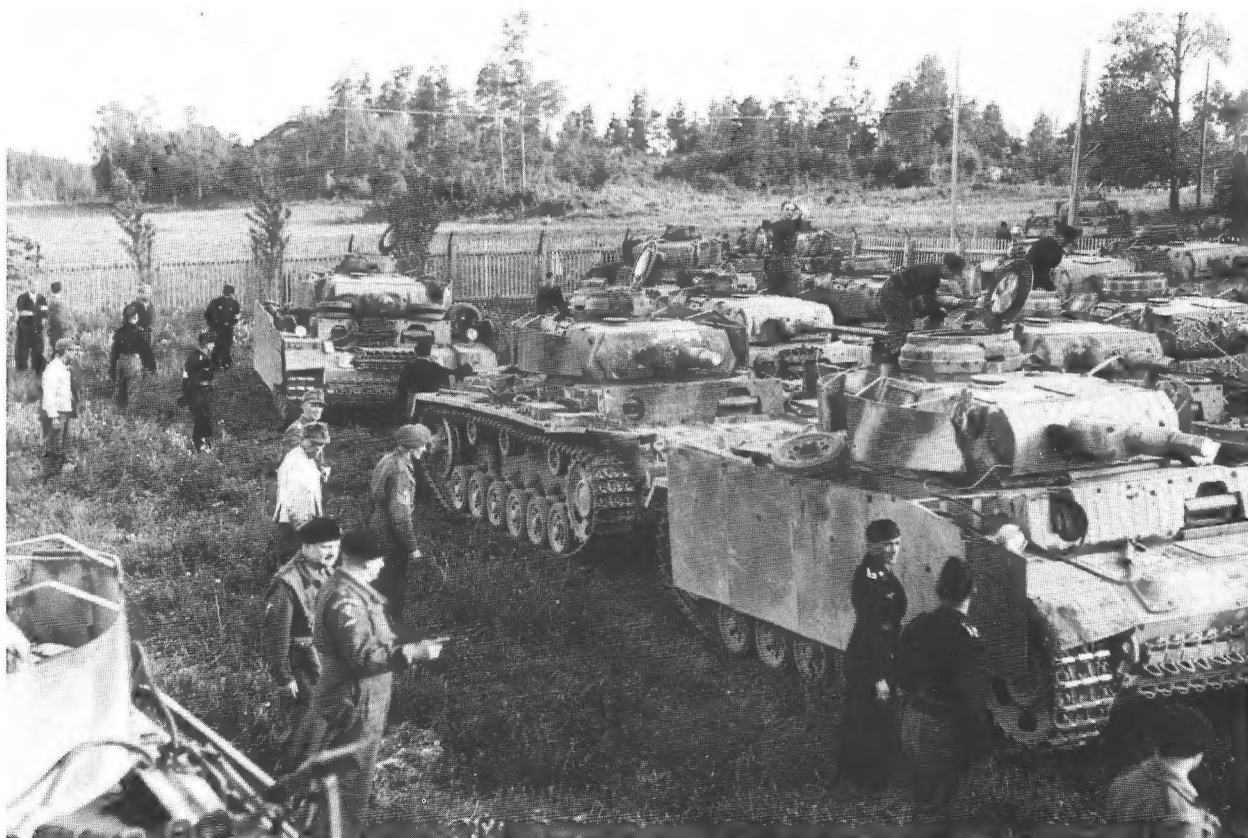
▲123 ▼124

**123.** German crews turn over their tanks outside Oslo, Norway, 10 June 1945. Most of the tanks are Pz Kpfw III Ausf Ns with zimmerit, schurzen and bolt-on armour, but there are several Ausf Js as well. Note the smoke-bomb dischargers on the turret sides of the vehicle in the foreground, and how all the muzzles have been capped.
